Coastal Subsidence in Kapoho, Puna, Island and State of Hawaii

Prepared for:
Hawaii County Planning Department

Dennis J. Hwang
Reinwald O'Connor & Playdon

January, 2007

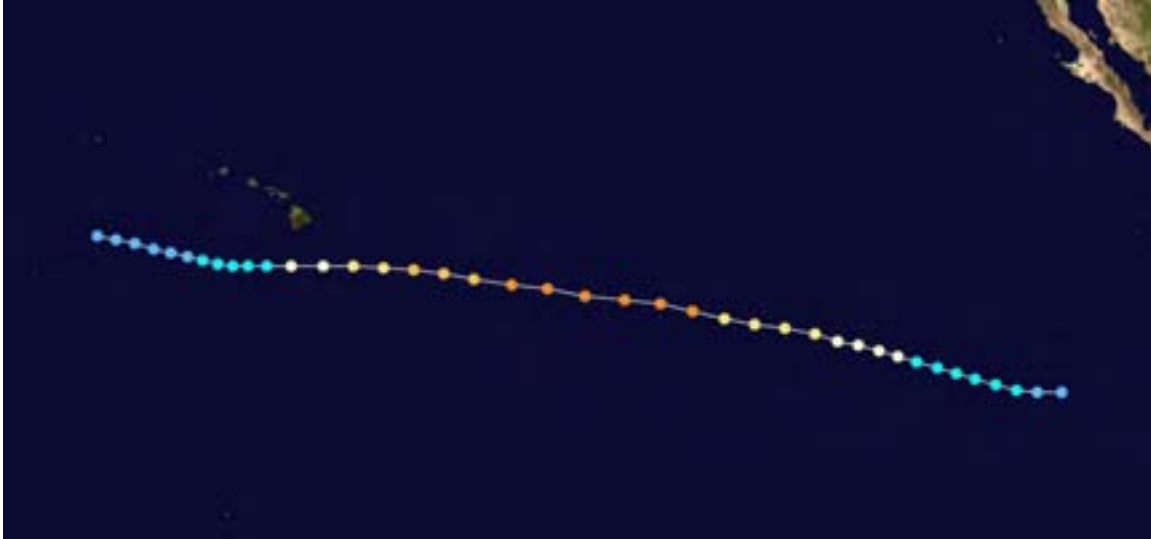
Figure 2-2 – Track of Hurricane Estelle from origination as a tropical storm in the east Pacific to the formation of a hurricane and passage south of Hawaii County as a category 1 hurricane (Graphic from Wikipedia).

Hurricane Estelle is a good example of the typical track for hurricanes in the Pacific. On July 22, 1986, the eye of Estelle passed over 100 miles south of Hawaii County (see Figure 2-2). In addition to the high spring tide, high waves generated from Estelle, crashed on the shores of the Big Island. There is no reason, from Figures 2-1 and 2-2 that Kauai would be more susceptible to hurricanes than Hawaii County.

Hurricane Estelle is again used to illustrate the point about the areas susceptibility to wind and wave setup, as well as storm events. From available reports regarding Hurricane Estelle, major damage in Hawaii occurred at the Vacationland area. The high waves washed away 5 beachfront homes and severely damaged dozens of others. According to records at the Hawaii County Planning Department, 18 houses suffered minor damage that totaled \$42,500. In addition, 12 houses had major damage that totaled \$194,000 and 7 houses were completely destroyed with an estimated property damage of \$160,883.

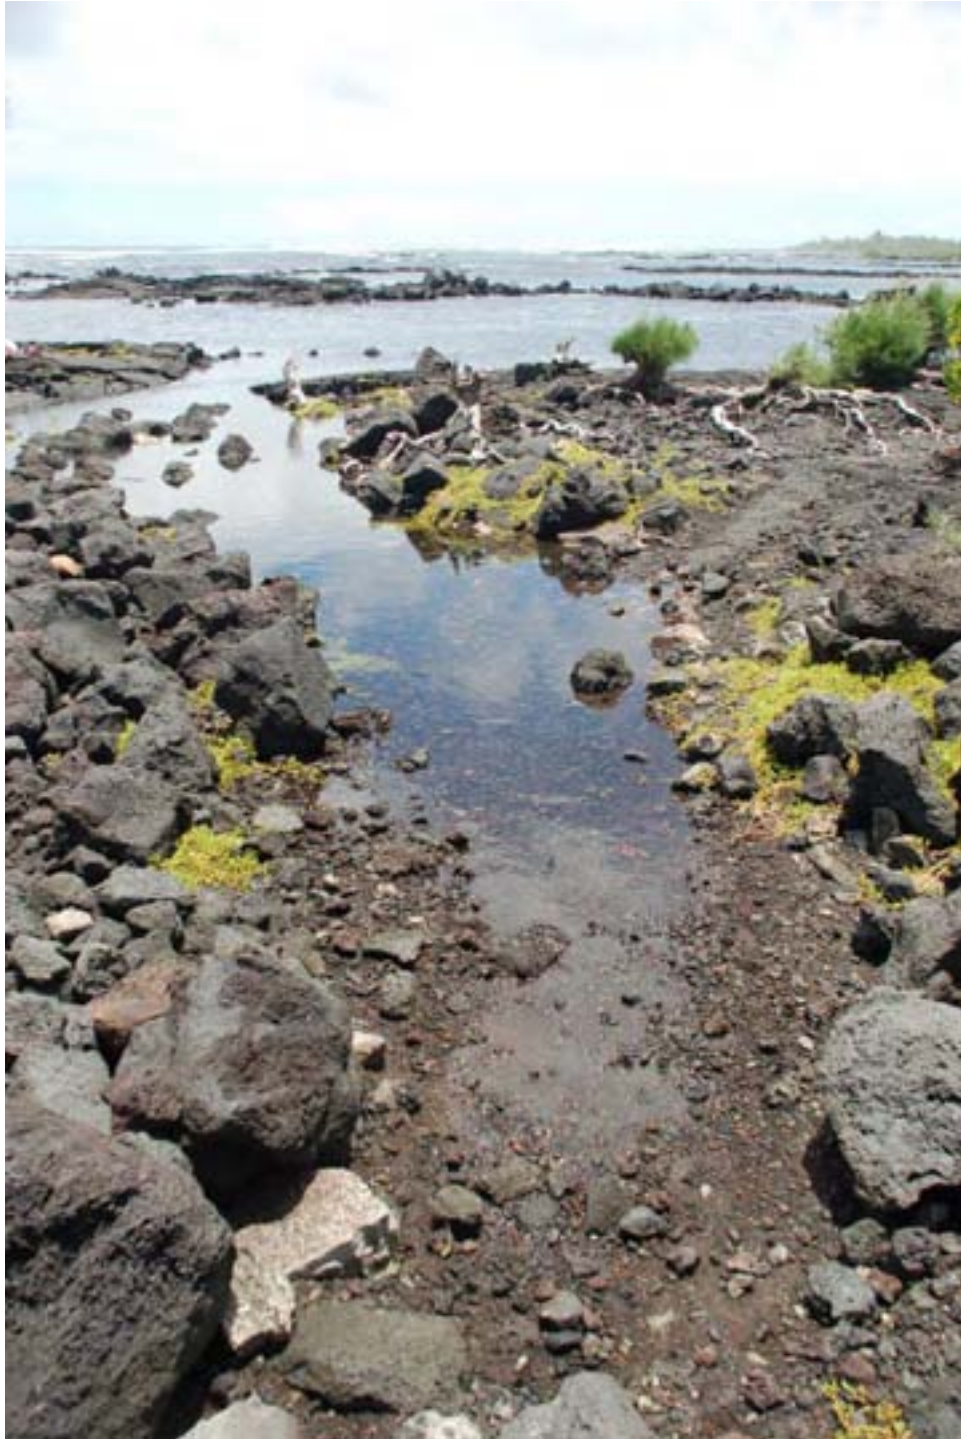
Figure 3-1 - At 12:30 pm on August 17, 2005, water is beginning to cross the channels in the lava makai of Waiopae Road. The lava topography, with numerous high and low areas, results in the creation of tidal channels, tidal pools and tidal islets. This area would be considered the inner pool area as designated in the Kapoho Reef watch study.

There are numerous low spots in the road. This may have been due to initial construction, but appears that the tidal currents passing over the road repeatedly served to cause erosion and make any low spots deeper than they originally may have been. Once the water crossed the road, it spilled over to low areas on the mauka side that are significantly below the road itself and this caused significant flooding (Figure 3-4). The flow of water to these mauka areas is more gravity flow of water than wave action as the limited depth of water over the road limits the wave action inland of the road.

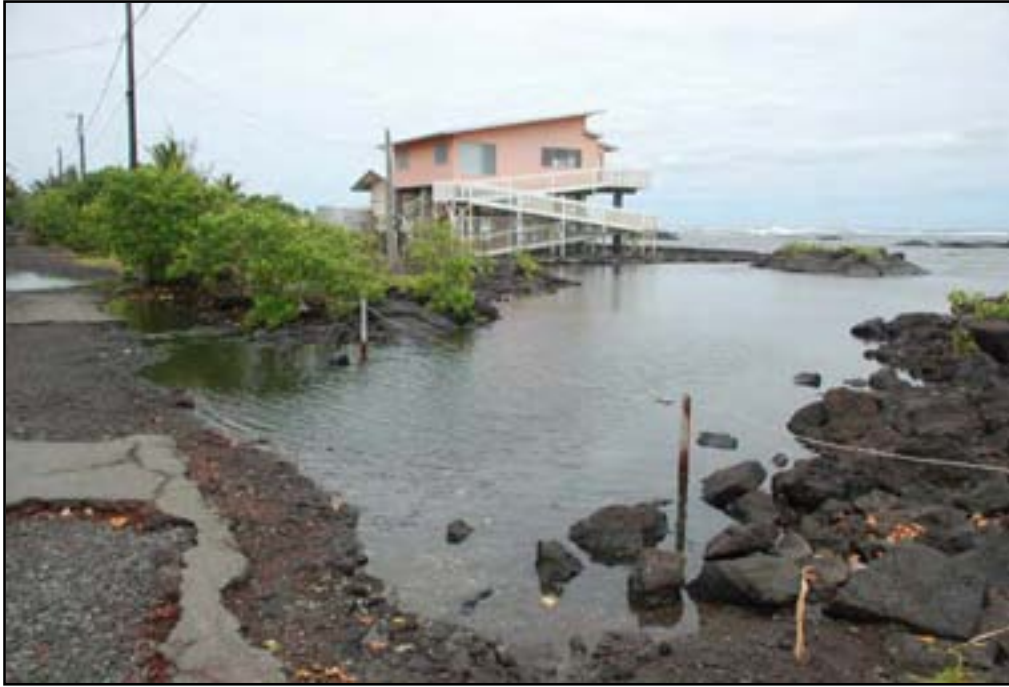
Figure 3-2. 12:57 PM. The incoming tide has filled the tidal channels and has crossed Waiopae Road in four low spots.

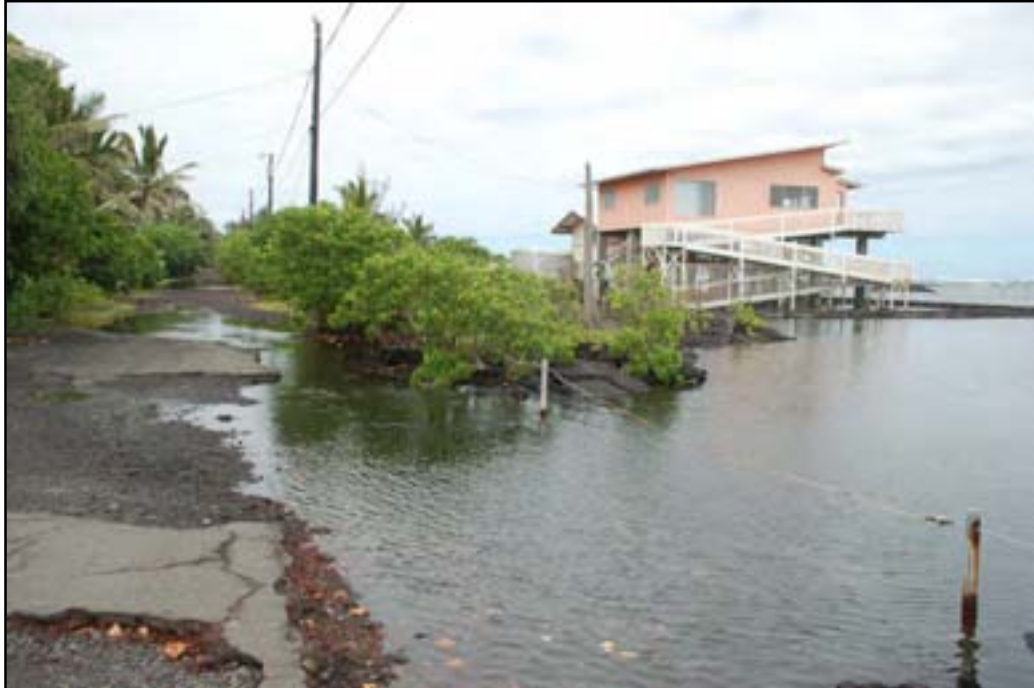
Figure 3-3 - 1:26 PM. – The tide is continuing to rise. Once crossing the road, the water spills over to lower areas mauka of the roadway, and floods properties mauka of the road.

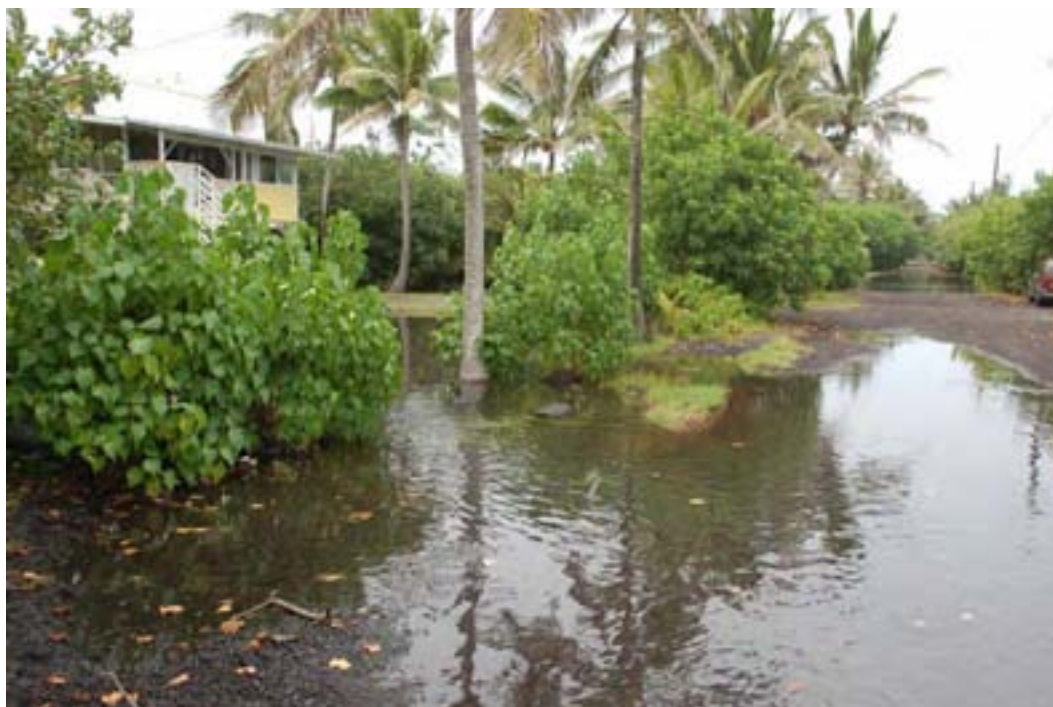
Figure 3-4 – Water overflowing the Waiopae Road and flooding the mauka lots.

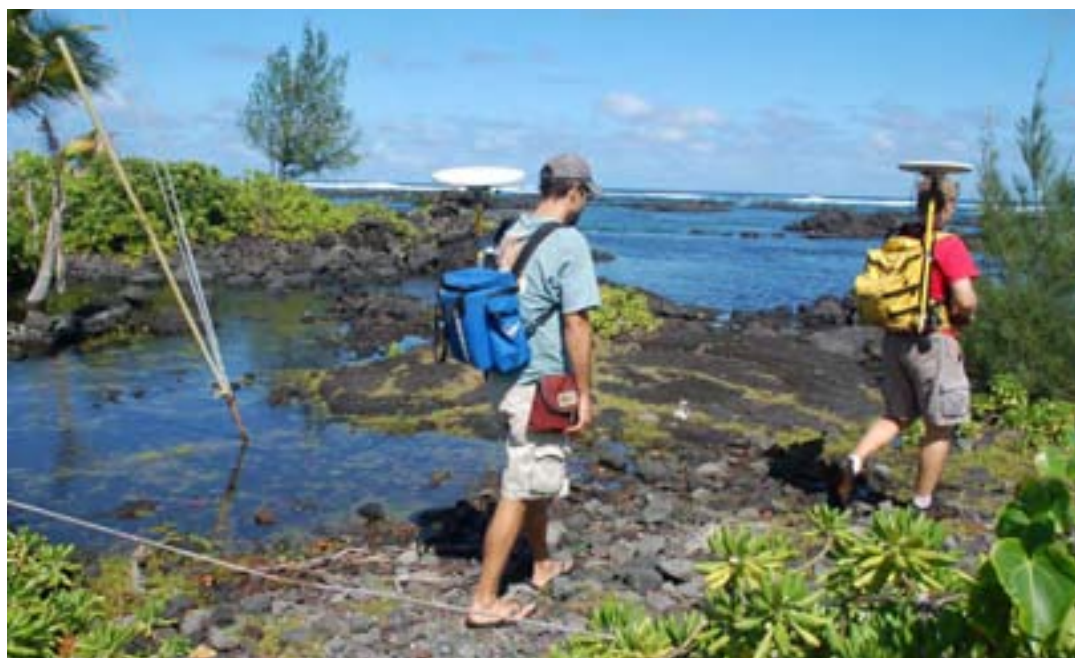
Figure 3-5 – Dual frequency satellite GPS units provide high accuracy in the vertical and horizontal dimension and were used to map the inundation levels for accessible areas.

Once high tide was reached for the August 17, 2005 event, the extent of inundation for accessible lots was marked with colored rope. The satellite GPS units were then used to record the position of the inundation event (Figure 3-5).

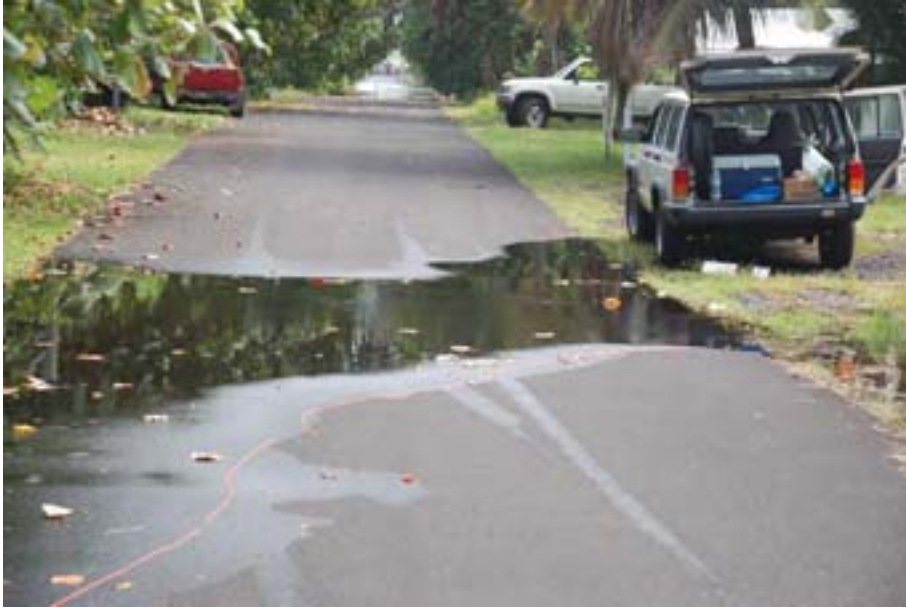
Figure 3-9 – Inundation near the intersection of Waipae Road and Kaheka Street on August 17, 2005. Maximum inundation is recorded by a cord. Predicted high tide is 3.17 feet above MLLW.

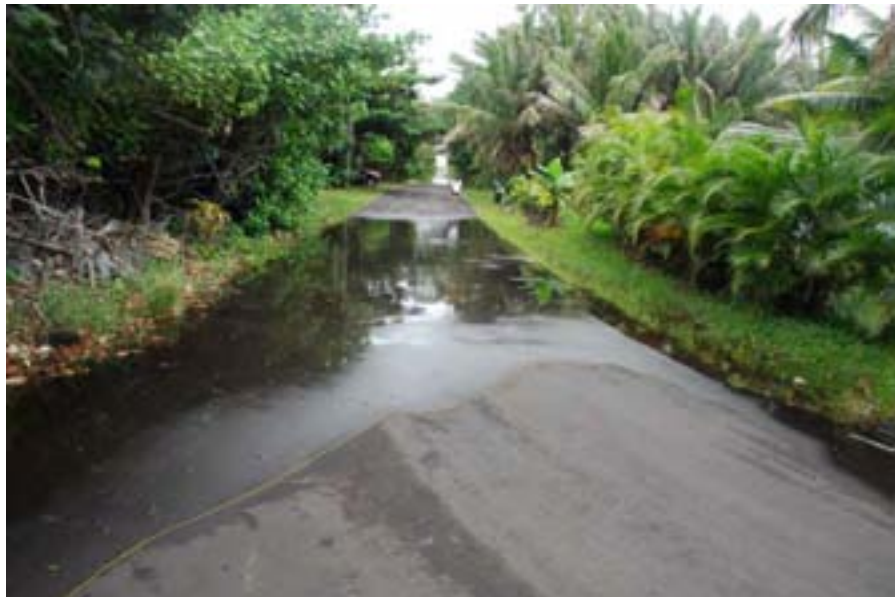
Figure 3-10 – Maximum inundation on July 10, 2006. Although the predicted high tide was less, at 3.13 above MLLW, the inundation is greater. This is attributed to stronger wind and wave setup, but subsidence could have also played a role. Depth of water at the maximum channel depth is $1 \frac{15}{16}$ of an inch or about 5 cm.

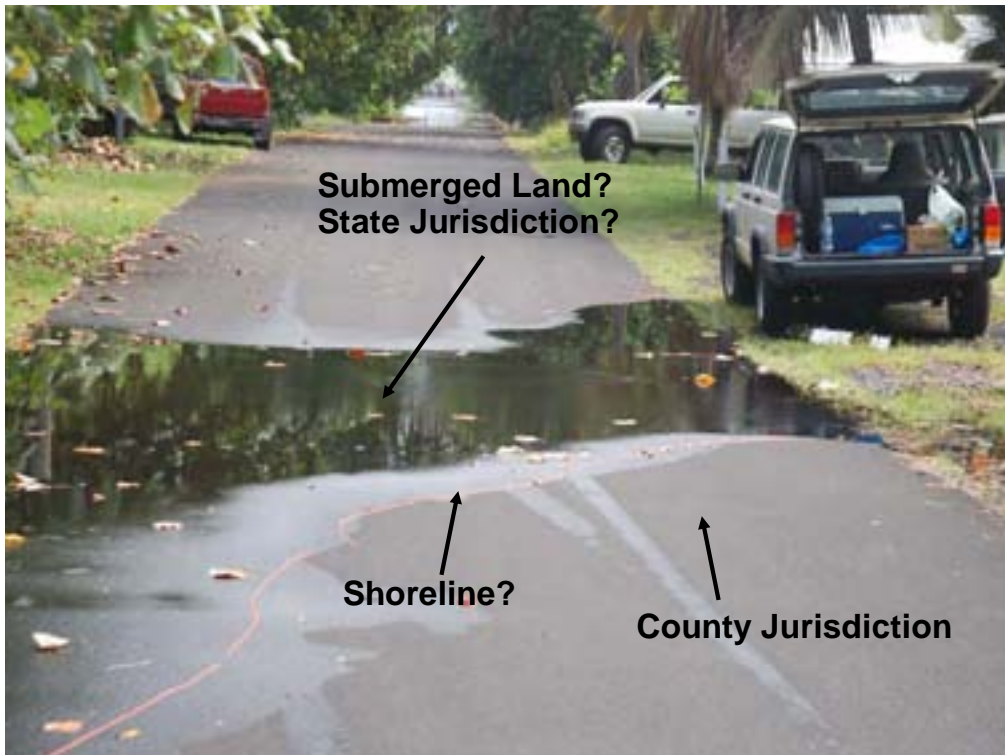
Figure 3-11 - During the high-tide event of August 17, 2005 – water crossed the makai ocean lots, and then the road, causing significant flooding of the mauka lots (right) as water spilled over from the road. Using surface connection to the ocean as a criteria to determine the shoreline can result in portion of the road being under State jurisdiction, while the majority is under county jurisdiction.

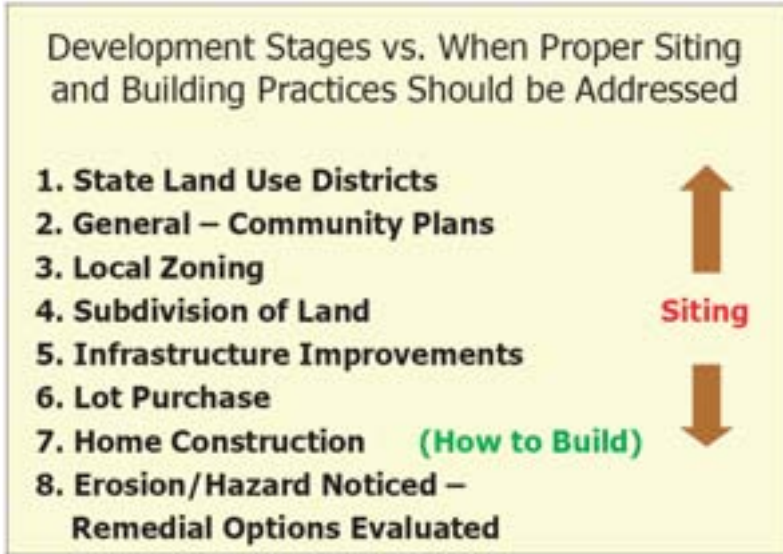
Figure 4-1 – From the Hawaii Coastal Hazard Mitigation Guidebook. Given the number of natural hazards in the Kapoho area, both siting and construction measures for hazard mitigation are recommended. Siting measures are best addressed at the early stages of development, e.g., during zoning, general and community plan changes and the process of subdivision.

development (i.e., zone changes, general and community plan amendments and the subdivision process). This report recommends that the issue of natural hazards be planned for at all stages of development as explained in the “Hawaii Coastal Hazard Mitigation Guidebook.”¹⁷ This is especially important if hazard mitigation measures for both siting and construction are to be implemented (Figure 4-1).

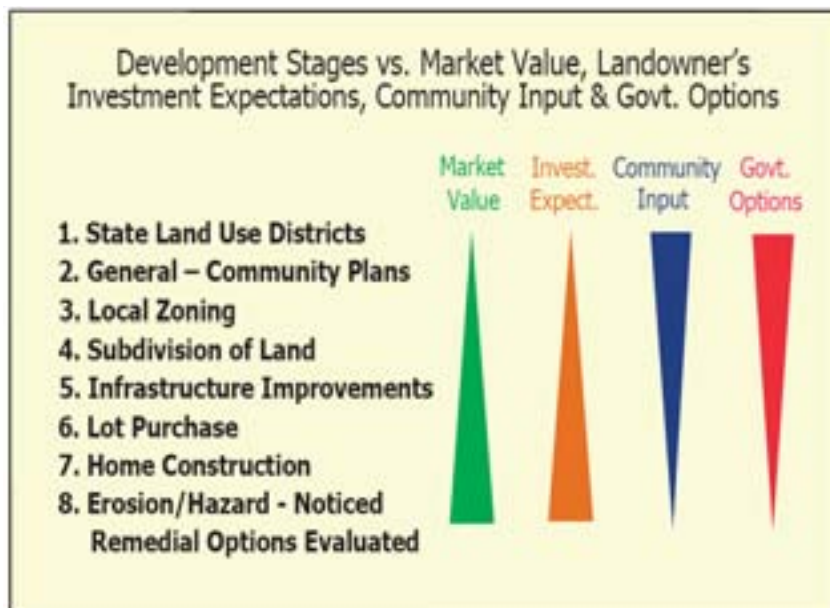
Figure 4-2 – From the Hawaii Coastal Hazard Mitigation Guidebook. As each stage in development proceeds, the landowner invests more time and money into the project. This serves to increase the market value of the property (column 1) and the investment backed expectations of the landowner (column 2), which is related to property rights. This will result in the community having less input into the project and the number of options the government has to reduce hazard risks will diminish (e.g., buying the property).

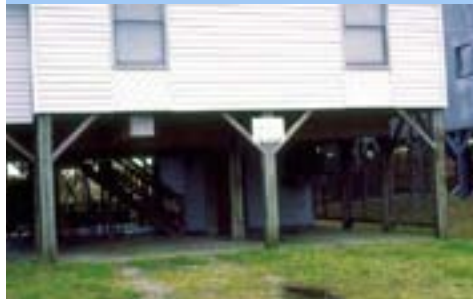
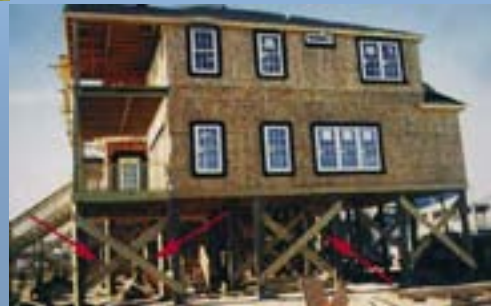
Knee Braces

Cross Braces

Figure 4-1 – Examples of Coastal Homes with Knee Braces and Cross Braces to strengthen columns or piers that are needed to elevate houses for flood or wave protection (from FEMA CCM).

While it was outside the scope of this study to analyze the adequacy of the building codes for Hawaii County, the building department should make sure that any structures elevated on piers and columns to mitigate the damage from flooding or wave action under the National Flood Insurance Program should also be able to handle anticipated earthquake risk. As expressed previously, this is important because there will be a tendency to build higher on piers and columns given the subsidence recorded in the area. Some measures to increase column strength can be found in the Federal Emergency Management Agency’s Coastal Construction Manual and includes the use of cross bracing or knee bracing (see Chapter 4).

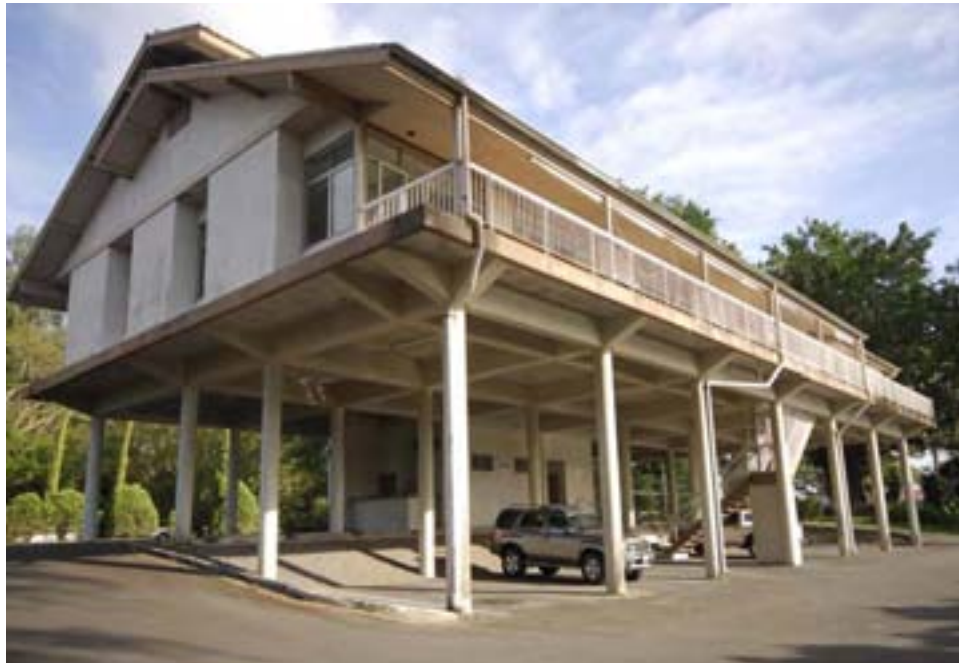
Figure 4-2 – Example of structure in Hilo designed for wave and flood action with modified knee braces on columns.

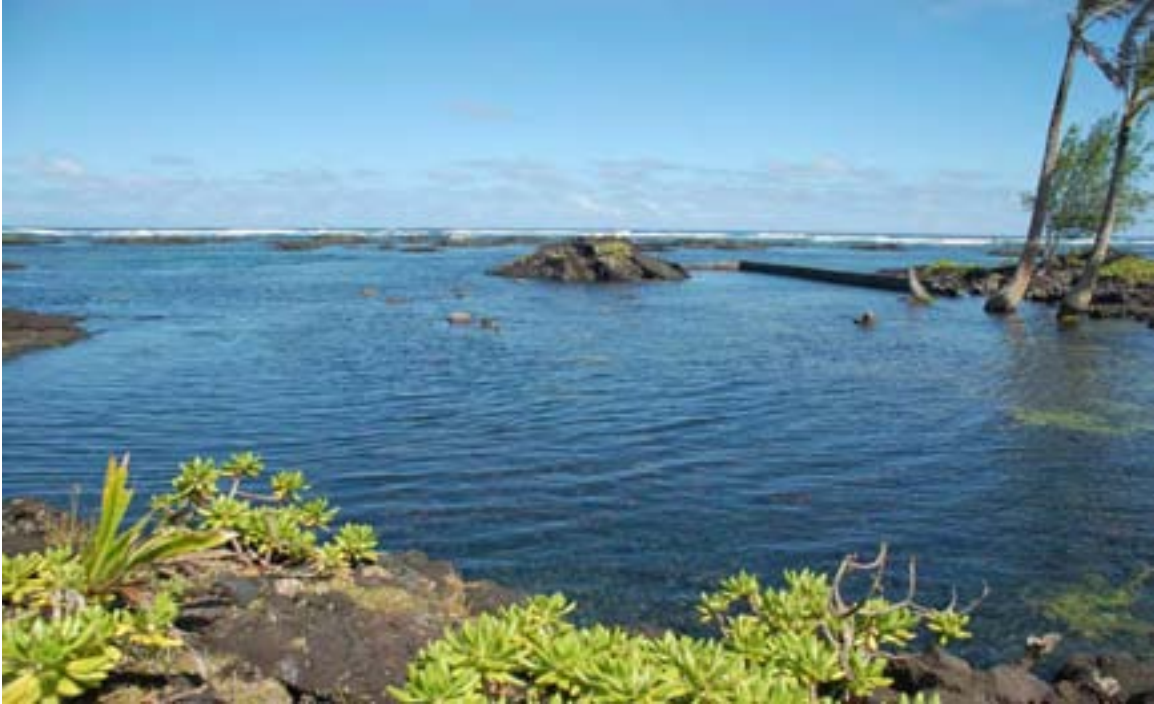
Figure 4-4 – On some makai lots at Kapoho, the land is submerged during extreme high tides, but the State is unlikely to make a claim for ownership of the land. One reason is that the natural topography on the lot results in portions being submerged while other parts or “islets” are dry and theoretically remain private property. It would be unlikely that the State would claim such land when there could be different ownership status for specific portions on the same lot. The land may remain private property while the possibility of building on it through a SMA or CDUA permit would be difficult.

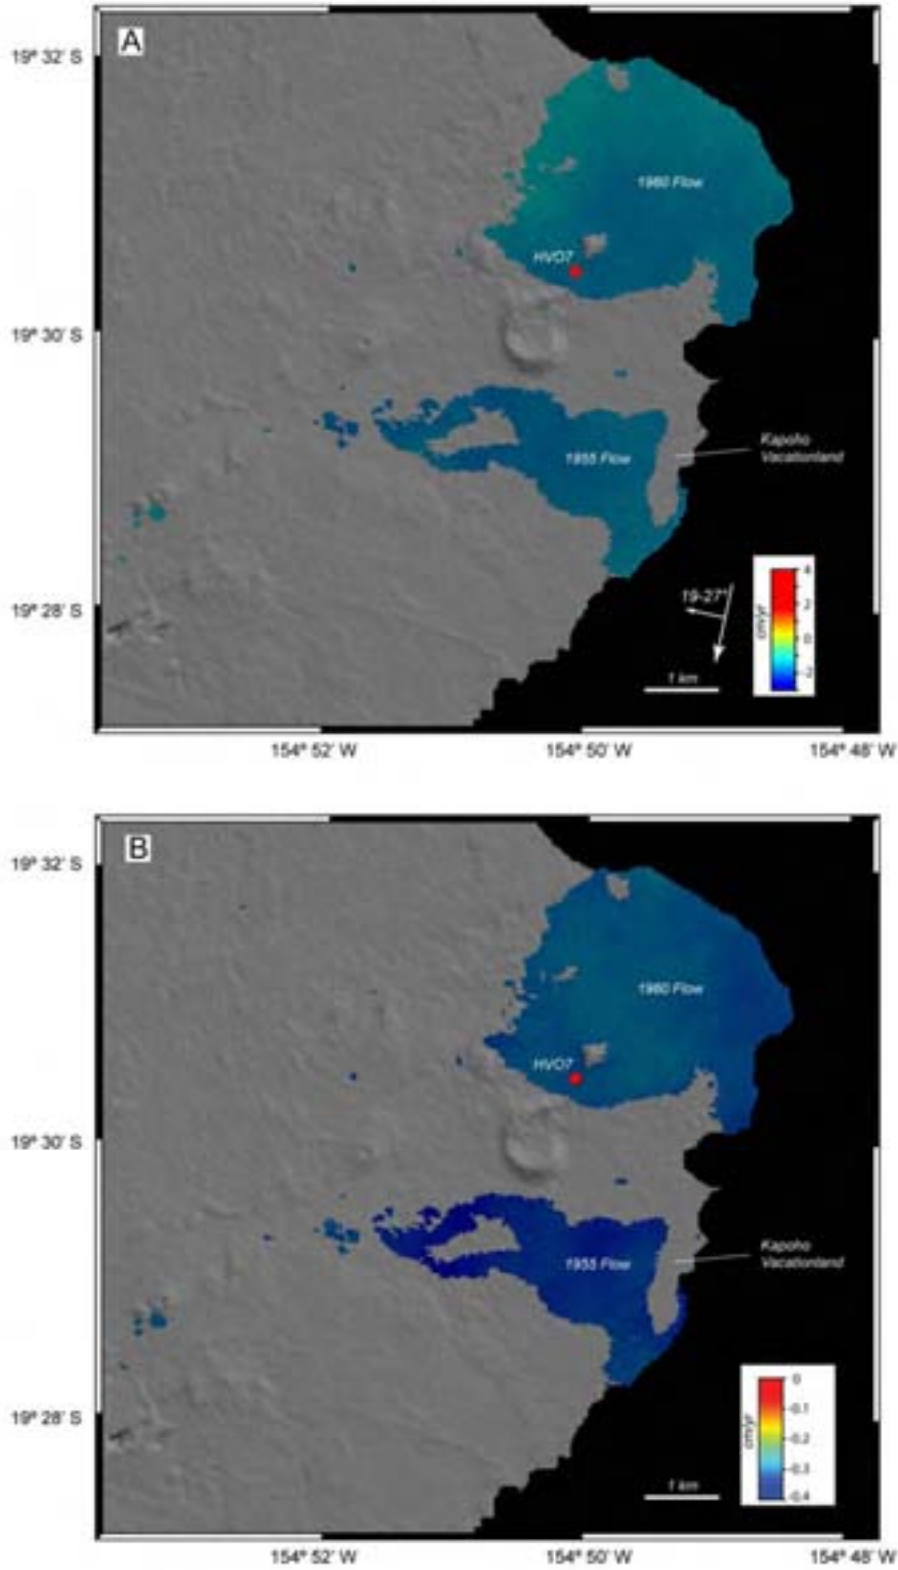
Figure A.2 Zoom for Kapoho region showing: A) LOS range change rate from Feb. 2003 to March 2006, B) Standard deviation of LOS displacement rate. Recent lava flows and GPS site indicated. Note the different scales between A and B.

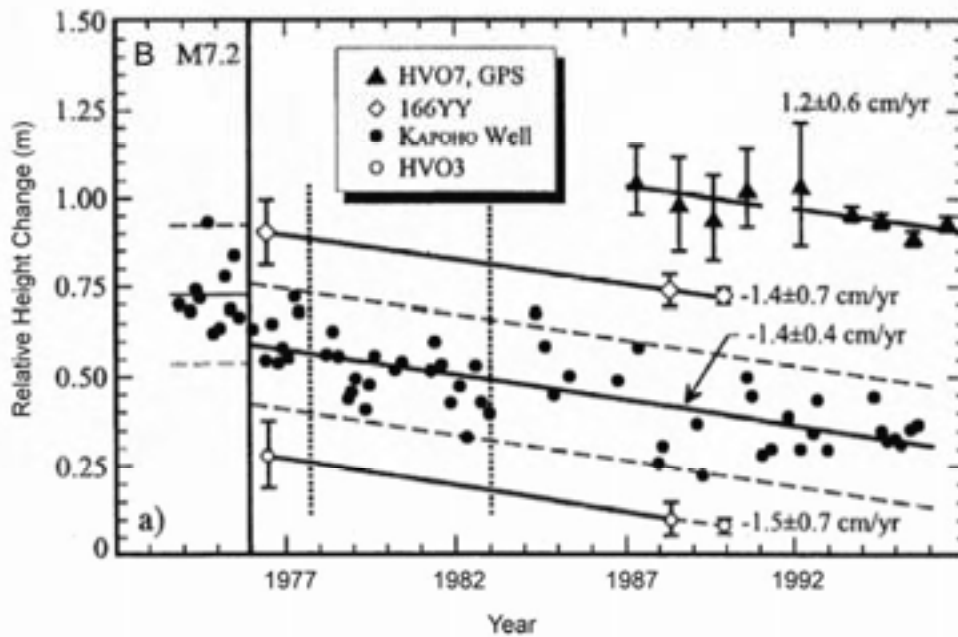
Figure A.4 Figures from Delaney et al. (1998) showing location and geodetic data from the Kilauea and Kapoho region. A) Location map with inset showing different types of data. B) Height (y axis) versus time (x axis) for geodetic data from the Kapoho region.

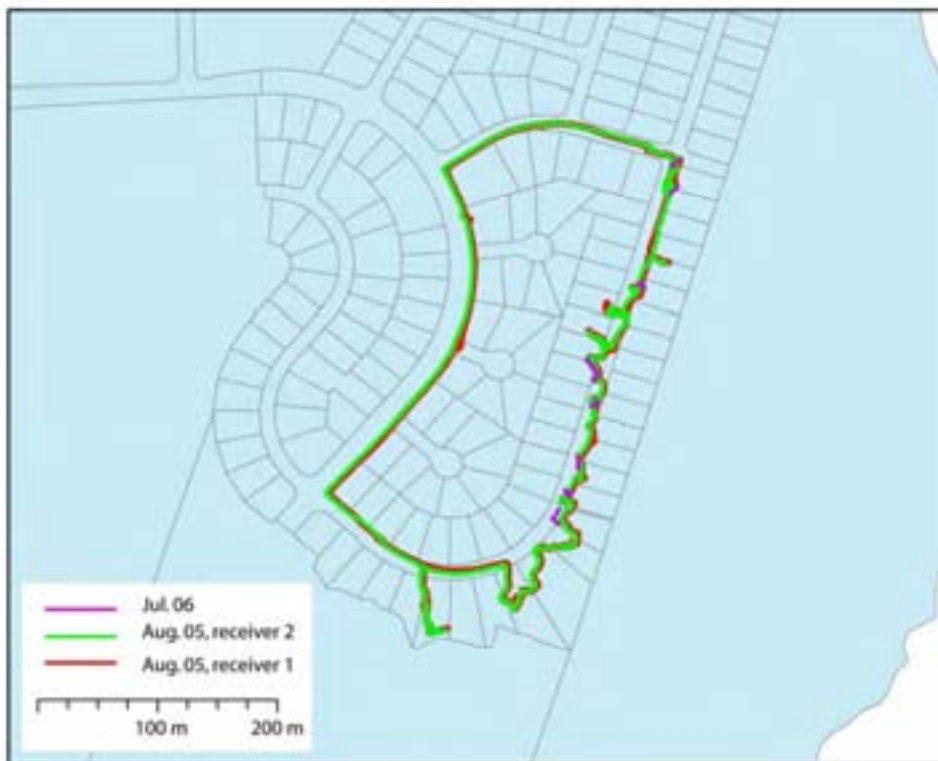
Figure A.6 Street map of Kapolo Vacationlands area with 3 GPS surveys superimposed. Legend indicates the color coding of each survey.
